Case study

Research on the failure of the induced draft fan's shaft in a power boiler

Jinfeng Du^{*}, Jun Liang, Lei Zhang

Center of Technology Research, Shenhua Guohua Electric Power Research Institute Co., Ltd, Beijing 100025, PR China

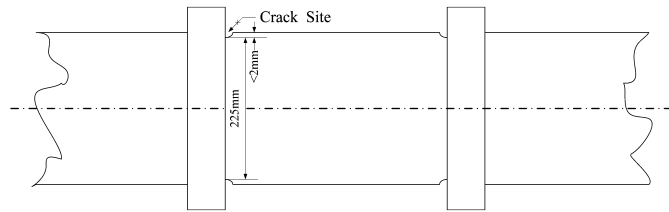
The induced draft fan of a power plant in 2012 suddenly appeared the abnormal phenomenon when it was running in condition of the variable frequency. The shaft of the induced draft fan was found to fracture after the emergency shutdown and the fracture happened near the site of the shaft's variable diameter. The shaft's smallest diameter was 225 mm and the chamfer of the shaft shoulder is less than 2 mm, as shown in Fig. 1. In this paper, the failure investigation had been paid attention to the analysis of failure cases which ranged from material performance, equipment's design to service condition of equipment, and thus the preventive measures were developed in order to avoid the recurrence of the similar failure.

Fig. 1. The schematic diagram of the cracking location on the shaft.

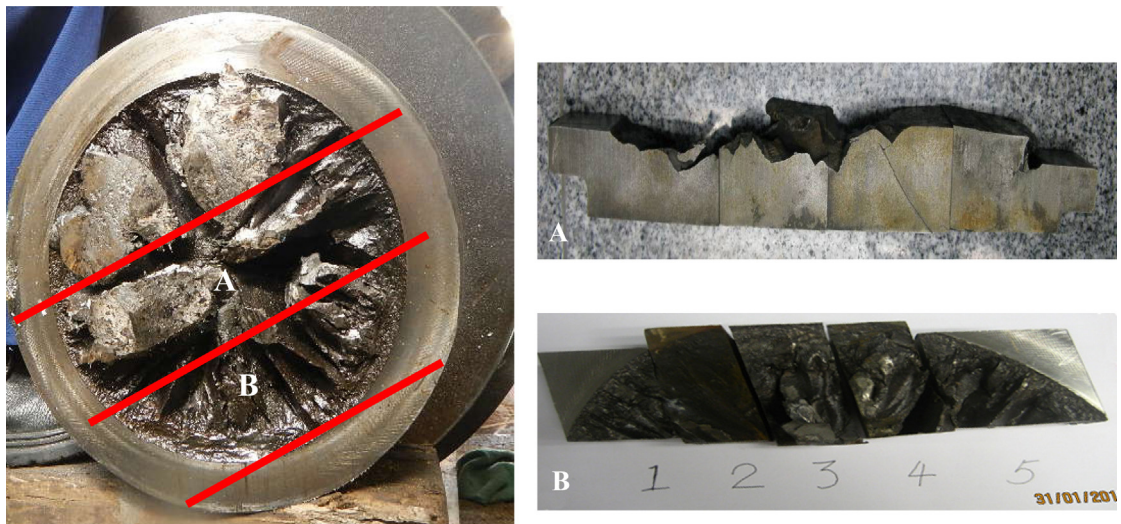
Specimens were taken from the fracture to carry out the metallurgical analysis and the SEM analysis, as shown in Fig. 3. The part A was used for the metallurgical analysis and the part B was used for the SEM analysis.

Fig. 3. The samples for metallographic and SEM analysis.

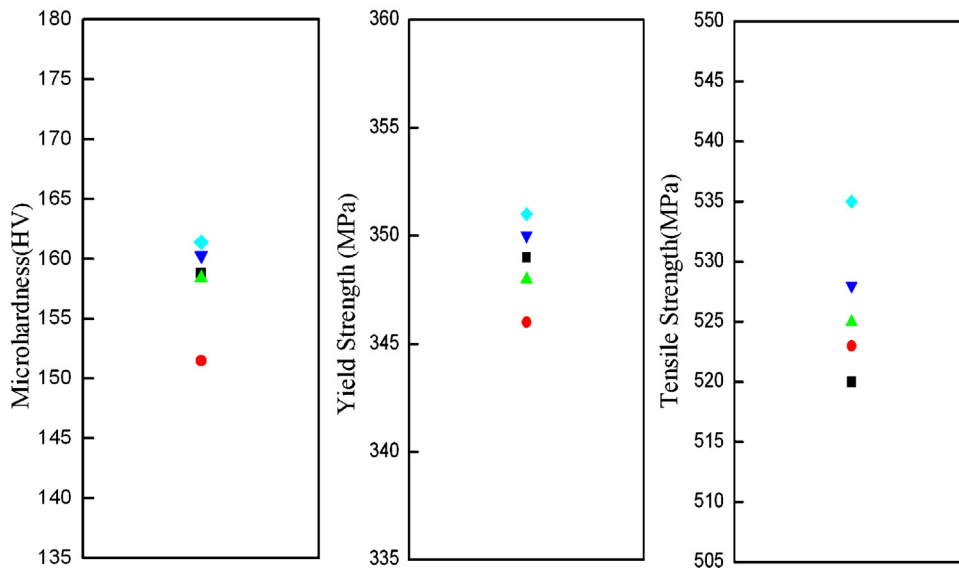
Fig. 4 showed the microhardness, yield strength and tensile strength of the failed material. The average of microhardness, yield strength and tensile strength were about 157 HV, 349 MPa and 527 MPa respectively, which showed the material property met the corresponding National standard [10]. That proved the material applied was good at the quality and the shaft failure was not relate to the material property.

Fig. 4. The mechanical property of the applied material.

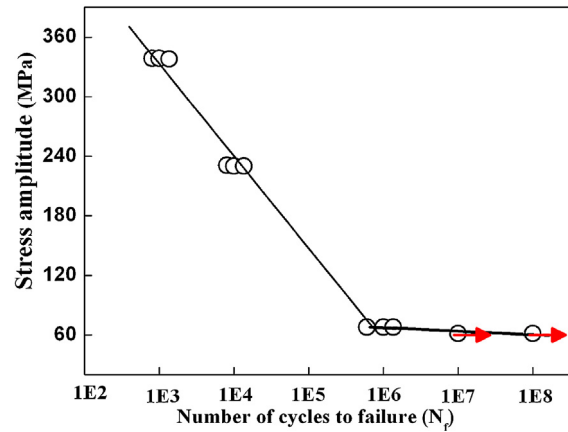
The S–N curve of Q345B based on the ultrasonic fatigue experiment was shown in Fig. 5. With the reduction of the stress level, the fatigue life increased gradually. But the cyclic time was always higher than 10^6 when the stress amplitude was lower than the shaft's fatigue strength (σ_{-1}) which was about 265 MPa. It was close to the value (269 MPa) which was calculated by following the equation [11]

Fig. 5. The applied material's S-N curves based on the ultrasonic fatigue.

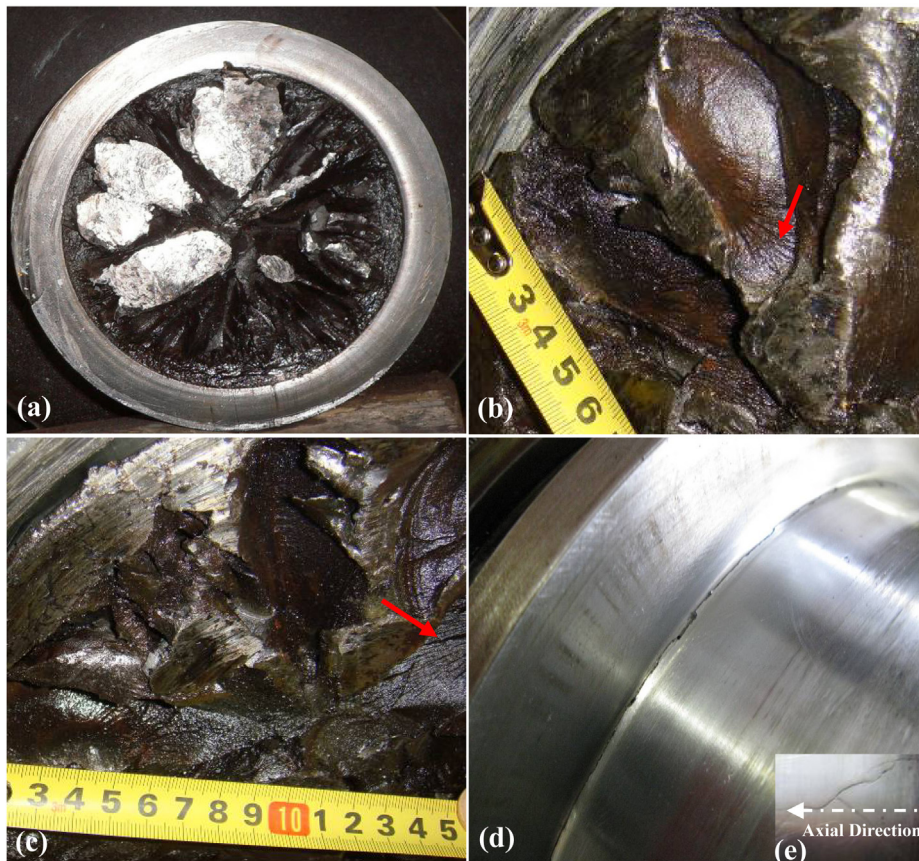
Fig. 6 showed the macroscopic feature of the shaft's fracture. From Fig. 6(a), the fracture was scraggly and it was more than 40 mm between the highest site and the lowest site for the fracture by means of the stereo microscope. So it was the

Fig. 6. The macroscopic feature of the shaft's fracture (a) whole fracture morphology; (b) beach marks; (c) fatigue cracks; (d) location of crack; (e) direction of crack growing.

typical morphology of the ratchet-like fracture. Some beach marks and fatigue cracks were observed, as shown in Fig. 6(b) and (c). Fig. 6(d) showed the cracks on the surface of other shaft which was same to the failed shaft from the view of material selection and service condition. Some cracks appeared at the surface of the shaft's shoulder chamfering and the crack grew along an angle of 45° to the axial direction, as shown in Fig. 6(e). It was confirmed that this shaft having cracks would fracture if it continued to work and the fractured position was also in the site of the minimum diameter.

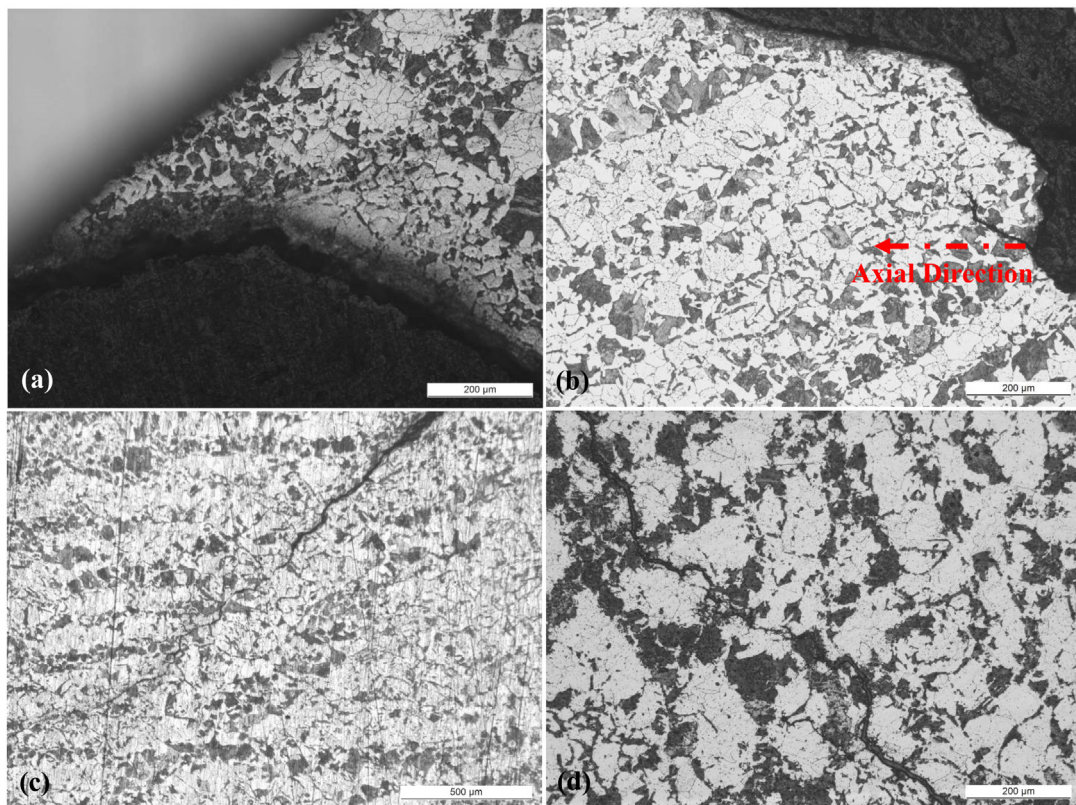
Fig. 8. The crack's initiation and propagation (a) the crack at the chamfer, (b) the secondary crack, (c) the crack's propagation (the longitudinal section), and (d) the crack's propagation (the cross section).

The crack's initiation and growth at the different section of the unfractured shaft were shown in Fig. 8. The crack initiated from the edge of the chamfer and grew along an angle of 45° to the axial direction. From Fig. 8(c) and (d), it was found that crack grew along the interface of the ferrite and the pearlite. So the interface was the weak position, the trend was intensified especially when the network pearlite had formed at the ferrite's boundaries.

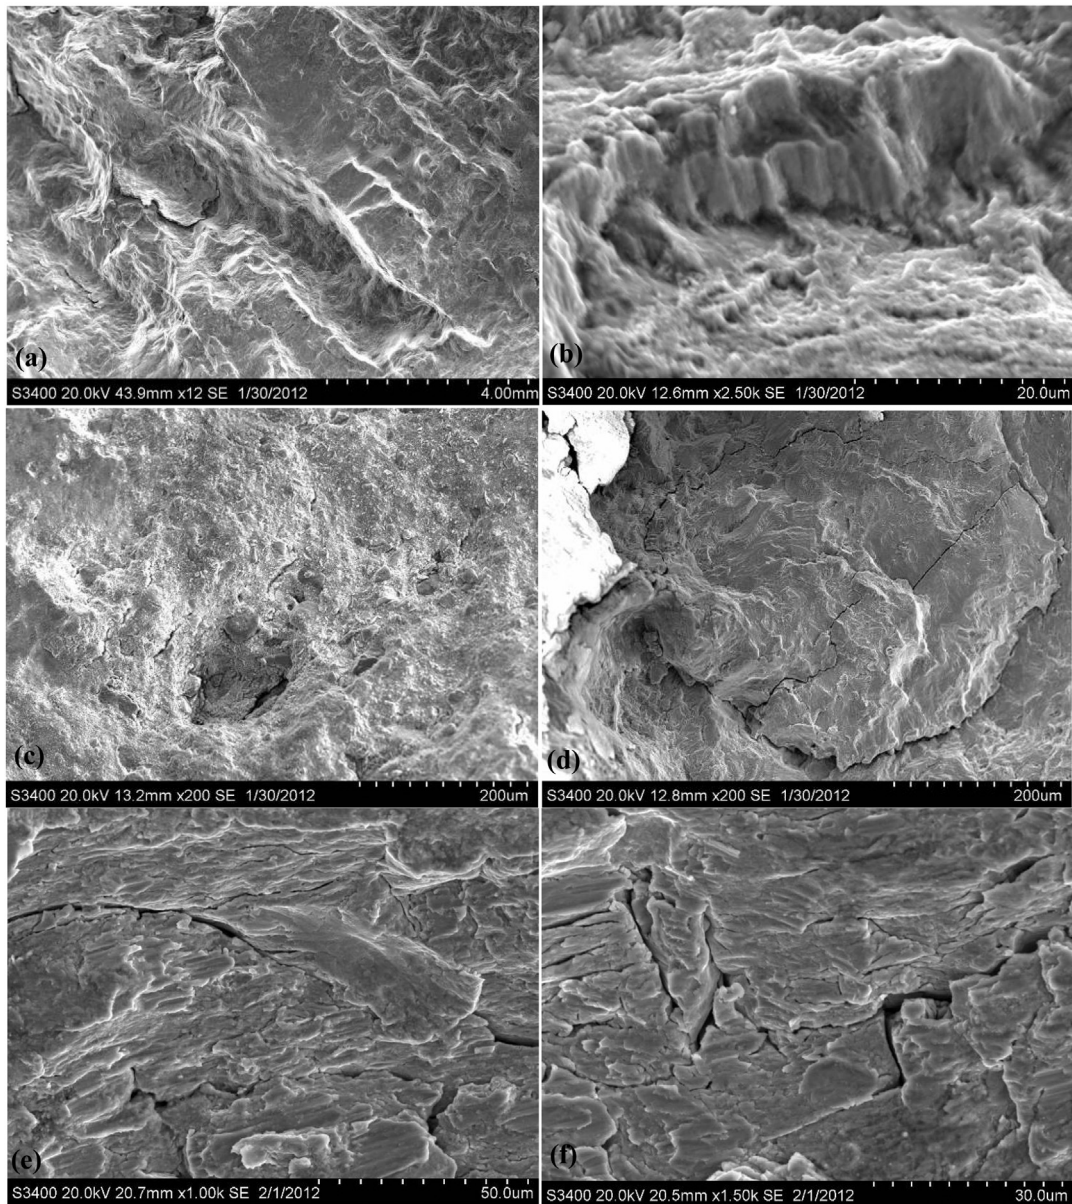
Fig. 9 showed the SEM images of the shaft's fracture. Most of fracture surface morphology were some torn edges, river pattern and small cleavage facets, so it confirmed the shaft's fracture was brittle fracture and the fracture showed the typical quasi-cleavage characteristic. The some secondary cracks appeared at the torn edge's bottom and the shallow dimple, and they was taken as the microcrack's source; some microcracks got together to form the crack, and the crack growth resulted in fracture. A large number of the multi-direction fatigue cracks were observed on the fracture's surface, and it was confirmed that the shaft underwent the fatigue damage which was caused by the vibration.

Fig. 9. The SEM images of the fracture (a) the torn edge, (b) the end of torn edge, (c) the shallow dimple, (d) the secondary crack around the shallow dimple, (e) the river pattern and (f) the fatigue crack.

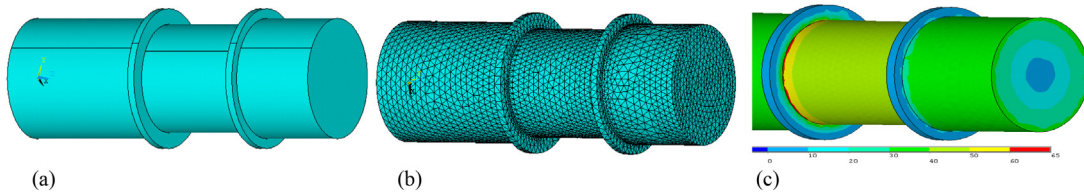
The shaft's solid model and the shaft's calculation model based on the finite element method were shown respectively in Fig. 10(a) and (b). The shaft's stress distribution obtained which is based on the induced draft fan's rated torque (58625 N m) was presented in Fig. 10(c), the stress concentration was significant at the site of the shaft shoulder's chamfer. The maximum shear stress (τ_{\max}) obtained by the ANSYS simulation was 63 MPa. The maximum allowable shear stress (τ_n) was obtained by the equation [11]

where τ_{\max} was the maximum shear stress, τ_n was the nominal maximum shear stress. Then k was 2.4 at the site of the shaft's variable diameter, and it was in a relatively high level. So this also proved that there existed the more significant stress concentration. Therefore the occurrence of fatigue failure at the shaft's variable diameter was earlier than other position.

Fig. 10. The shaft's solid model and the shaft's calculation model based on the finite element method (a) solid model, (b) calculation model, and (c) stress distribution.

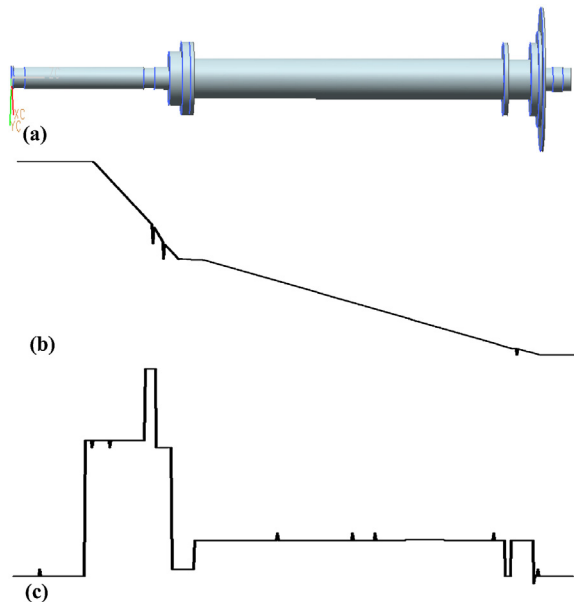
The shaft's three-dimensional model was built based on the design size, as shown in Fig. 11(a). The result calculated with applying the lumped mass method showed that the order torsional vibration was anomalous at the shaft's smallest diameter when the shaft was in the critical speed (920 rpm), and the torsional stress was maximal at the smallest diameter.

Fig. 11. The shaft's three-dimensional model and the order torsional vibration's mode and the torsional stress distribution (a) the three-dimensional model, (b) the order torsional vibration's mode, and (c) the torsional stress distribution.
